(10) **Patent No.:** **US 9,303,515 B2**
(45) **Date of Patent:** **Apr. 5, 2016**

(54) **TURBOMACHINE DIAPHRAGM AND
METHOD OF REPAIRING A
TURBOMACHINE DIAPHRAGM**

(73) Assignee: **GENERAL ELECTRIC COMPANY**,
Schenectady, NY (US)

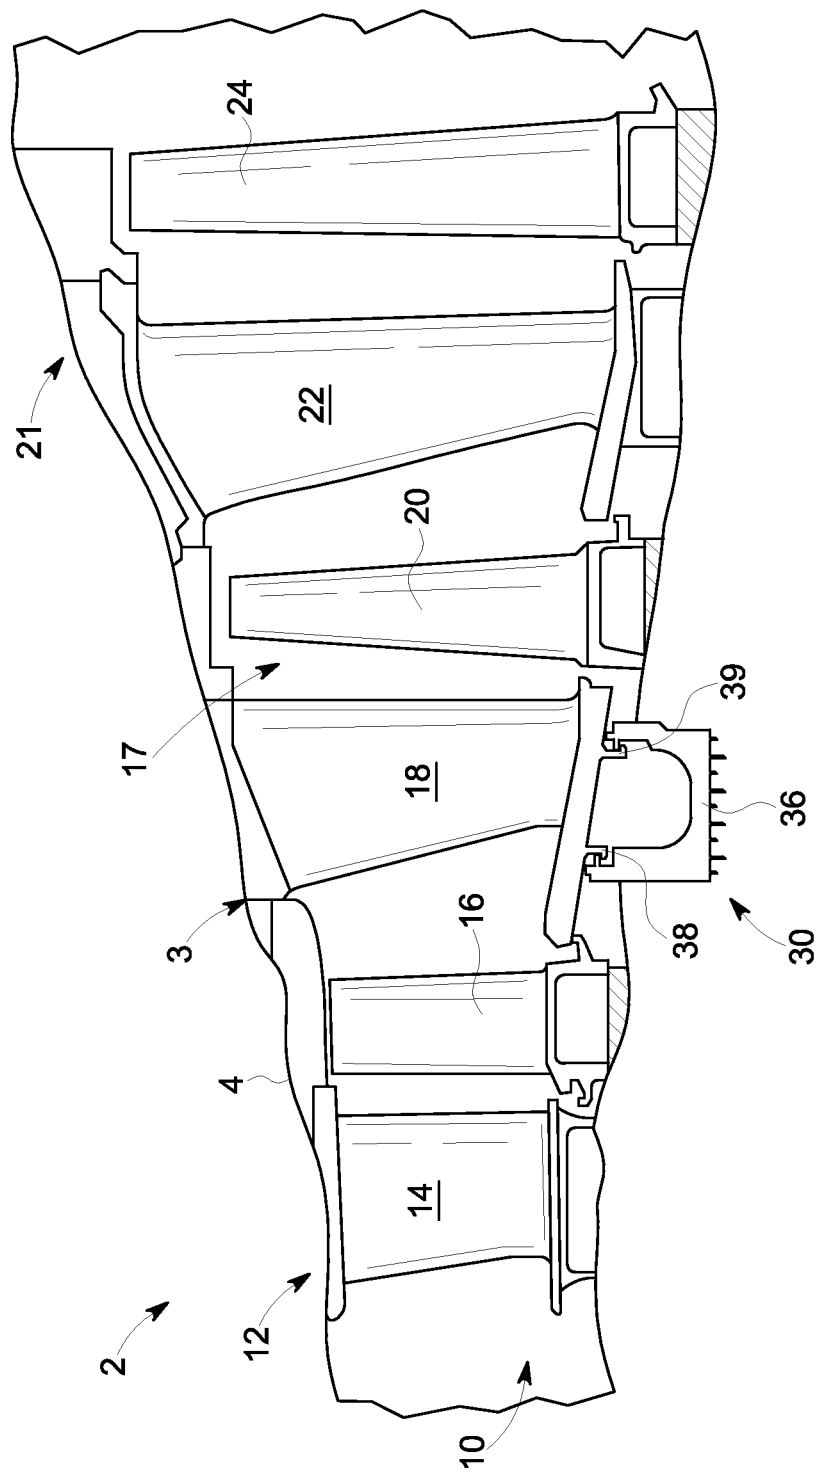
FIG. 1 is a schematic view of a turbomachine including a diaphragm in accordance with an exemplary embodiment;

Referring to FIG. 1, a turbomachine, in accordance with an exemplary embodiment, is indicated generally at 2. Turbomachine 2 includes a turbine portion 3 having a housing 4 that defines, at least in part, a hot gas path 10. Turbine portion 3 includes a first stage 12, having a plurality of first stage vanes or nozzles 14, and first stage buckets or blades 16; a second stage 17 having a plurality of second stage vanes or nozzles 18 and second stage buckets or blades 20; and a third stage 21 having a plurality of third stage vanes or nozzles 22 and third stage buckets or blades 24. Of course it should be understood that turbine portion 3 could also include additional stages (not shown).

Hot combustion gases flow axially along hot gas path 10 through nozzles 14, 18, and 22, impact and rotate blades 16, 20, and 24. In addition, a cooling airflow is guided into a wheelspace (not separately labeled) of turbine portion 3. The

cooling airflow, typically from a compressor portion (not shown) is directed through various components of turbine portion 3 to reduce localized hot spots, improve wear, and increase an overall component life. Each nozzle 14, 18, and 22 includes a corresponding diaphragm, one of which is shown at 30, that provides a seal which prevents hot gases from passing from hot gas path 10 into the wheel space. Diaphragm 30 cooperates with additional structure, (not shown), to limit ingestion of hot gases into the wheel space. Loss of hot gases from hot gas path 10 into the wheel space reduces operational efficiency of turbine portion 3. Over time, portions of diaphragm 30 may become worn and require localized repair as will be discussed more fully below.

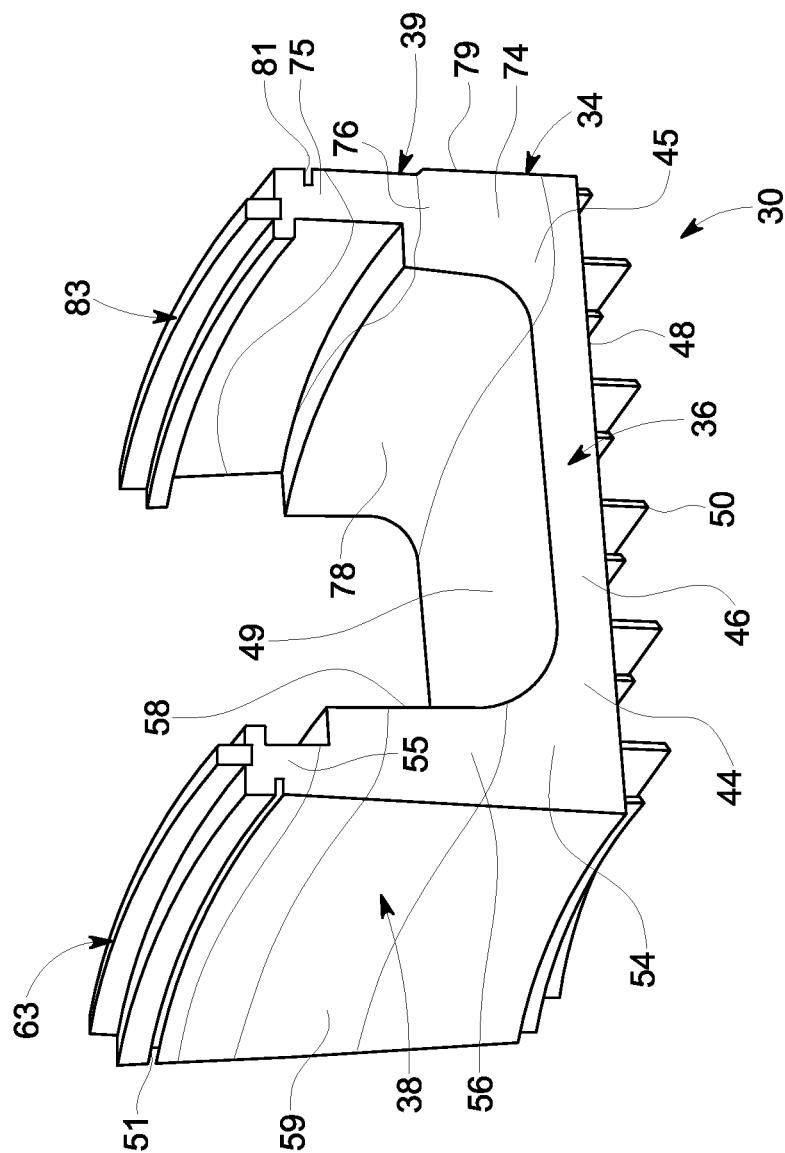
FIG. 2 is a perspective view of a diaphragm including a repair coupon in accordance with an exemplary embodiment;

Reference will now follow to FIG. 2 in describing a repaired diaphragm 30 in accordance with one aspect of an exemplary embodiment. Repaired diaphragm 30 includes a body 34 having a sealing section 36, a first rail member 38 and a second rail member 39. Sealing section 36 includes a first end portion 44 that extends to a second end portion 45 through an intermediate portion 46 that defines an outer surface portion 48 and an inner surface portion 49. Outer surface portion 48 is provided with a plurality of seal elements 50 that cooperate with additional structure (not shown) arranged in the wheel space of turbine portion 3. First rail member 38 extends from first end portion 44 and second rail member 39 extends from second end portion 45. First rail member 38 includes a first end section 54 that extends to a second end section 55 through an intermediate section 56 that defines an inner surface section 58 and an outer surface section 59. Outer surface section 59 includes a discourager seal mounting section 51 that supports a discourager seal (not separately labeled). Second end section 55 supports a repair coupon 63. Repair coupon 63 replaces the original coupon (not shown) that was provided on first rail member 38. As will become more fully evident below, repair coupon 63 is joined to first rail member 38 using a variety of techniques.

Similarly, second rail member 39 includes a first end section 74 that extends to a second end section 75 through an intermediate section 76 that defines an inner surface section 78 and an outer surface section 79. Outer surface section 79 includes a discourager seal mounting section 81 that supports a discourager seal (not separately labeled). Second end section 75 supports a repair coupon 83 that replaces the original coupon (not shown) provided on second rail member 39. More specifically, over time the original coupons wear. Worn coupon may allow hot gasses to flow from hot gas path 10 into the wheel space or other regions of the turbomachine. The loss of gases from the hot gas path 10 reduces turbine efficiency. Accordingly, diaphragms are either repaired or replaced during a maintenance interval. In accordance with the exemplary embodiment, instead of a labor intensive repair of the original coupon, the exemplary embodiment discloses various techniques for replacing the original coupon with a repair coupon.

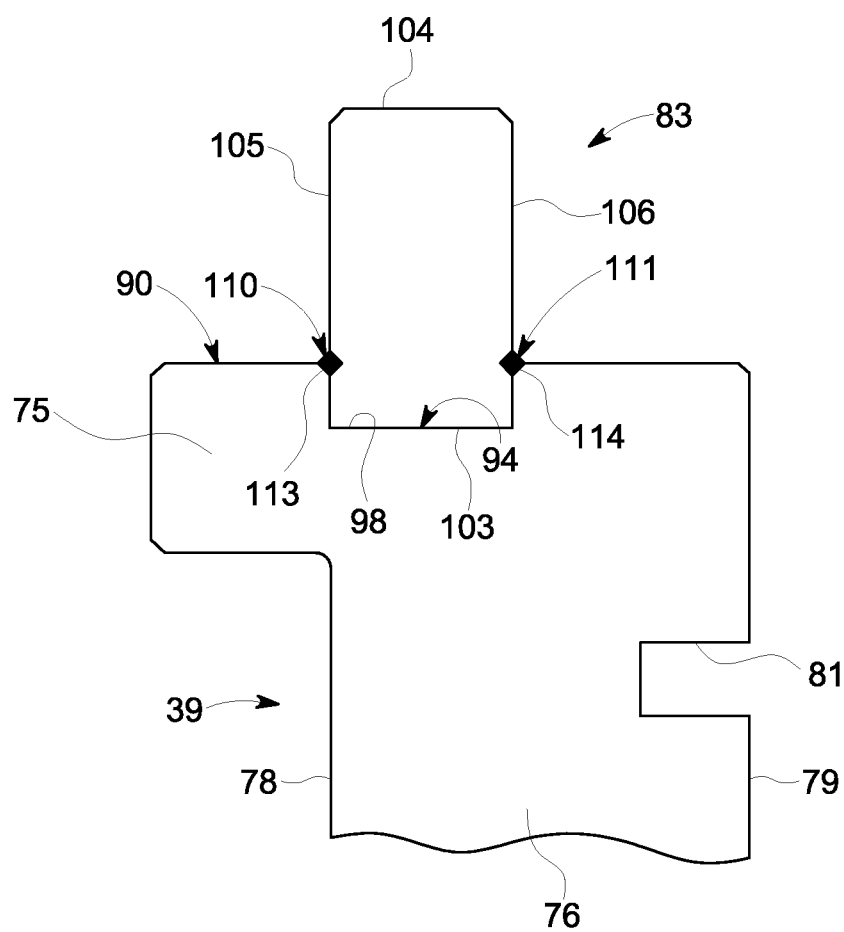
FIG. 3 is a partial plan view of a repair coupon mounted to a diaphragm rail member in accordance with one aspect of the exemplary embodiment;

Reference will now be made to FIG. 3 in describing repair coupon 83 with an understanding that repair coupon 63 is bonded to first rail member 38 in a similar manner. Second end section 75 includes a machined surface 90 including a repair coupon mounting element 94. More specifically, second end section 75 is machined to remove the original coupon and form repair coupon mounting element 94. In the exemplary embodiment shown, repair coupon mounting element 94 takes the form of a slot 98 having a substantially rectangular profile formed in machined surface 90. With this arrangement, repair coupon 83 is positioned within slot 98 and bonded to second rail member 39. More specifically, repair coupon 83 includes first and second opposing ends 103

and 104 that are joined by first and second opposing sides 105 and 106 forming a substantially rectangular cross-section. First end 103 is nested within slot 98. A first metallurgical bond 110 is formed between second end section 75 and first side 105 and a second metallurgical bond 111 is formed between second end section 75 and second side 106. Metallurgical bonds 110 and 111 take the form of welds 113 and 114 that bond repair coupon 83 to second rail member 39.

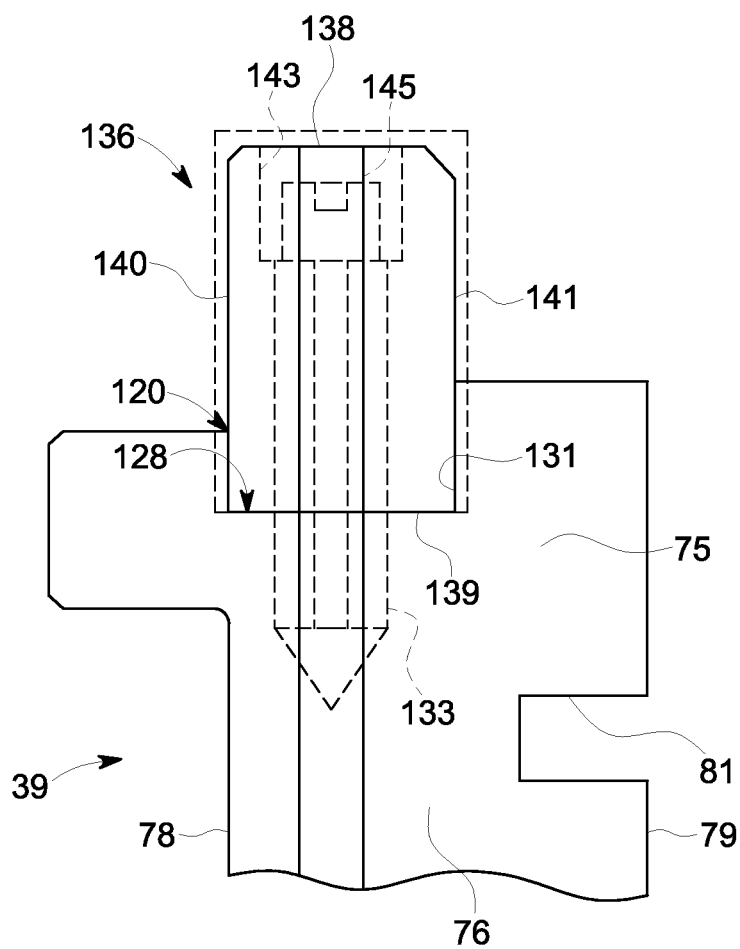
FIG. 4 is a partial plan view of a repair coupon mounted to a diaphragm rail member in accordance with another aspect of the exemplary embodiment;

Reference will now be made to FIG. 4, wherein like reference numbers represent corresponding parts in the respective views, in describing second end section 75 of second rail member 39 in accordance with another aspect of the exemplary embodiment. Second end section 75 is processed to remove the original coupon and form a machined surface 120. A repair coupon mounting element 128 is formed in machined surface 120. Repair coupon mounting element 128 takes the form of a slot 131 including one or more threaded openings 133. A repair coupon 136 is mounted in slot 131 and joined to second end section 75. Repair coupon 136 includes first and second opposing ends 138 and 139 joined by first and second opposing sides 140 and 141 forming a generally rectangular cross-section. Repair coupon 136 includes a central opening 143 that is configured to align with threaded opening 133 formed in slot 131. A mechanical fastener 145 is passed through central opening 143 and engaged with threaded opening 133 to bond repair coupon 136 to second end section 75. It should be understood that the number of mechanical fasteners and associated structure may vary.

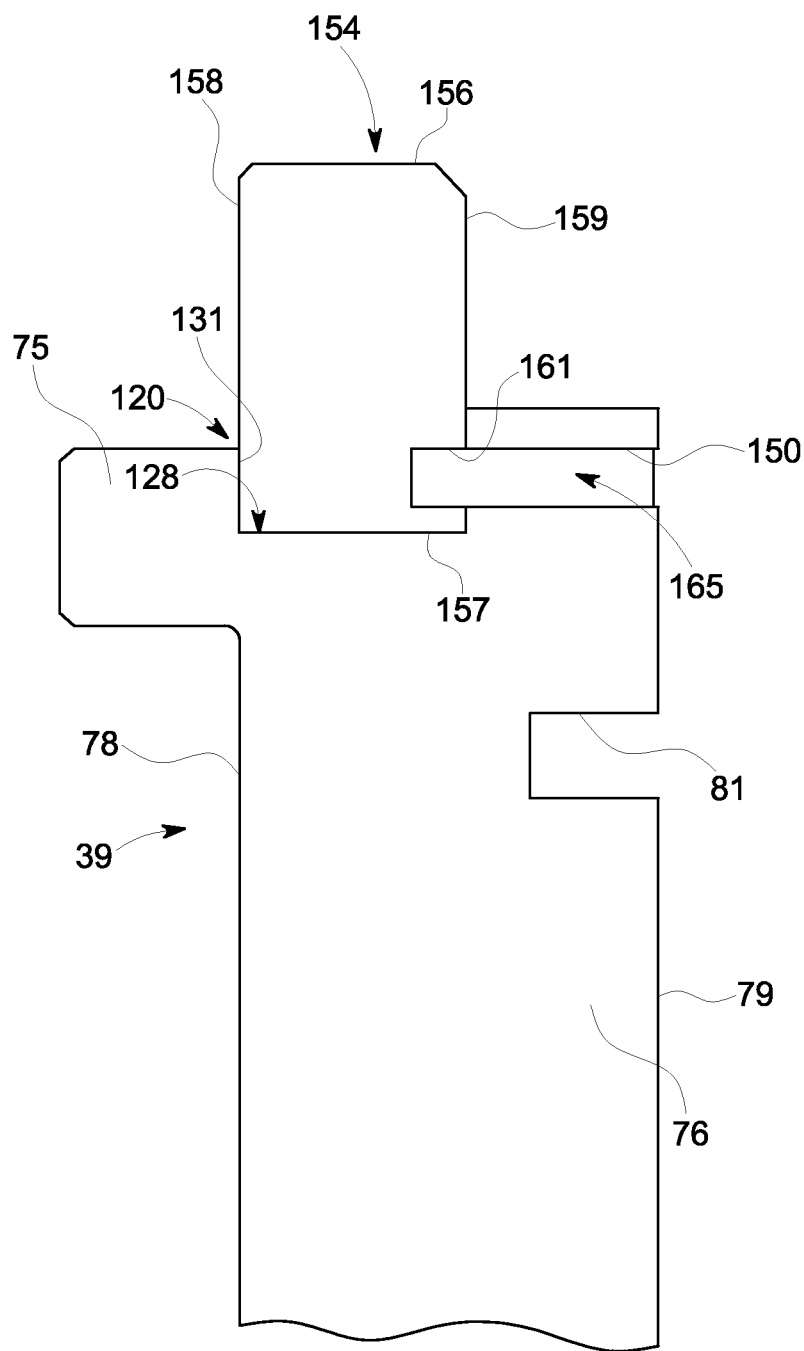
FIG. 5 is a partial plan view of a repair coupon mounted to a diaphragm rail member in accordance with yet another aspect of the exemplary embodiment;

FIG. 5, wherein like reference numbers represent corresponding parts in the respective views, illustrates an opening 150 formed in second rail member 39. Opening 150 extends from outer surface section 79 into slot 131. With this arrangement, a repair coupon 154 is positioned in slot 131 and joined to second end section 75. Repair coupon 154 includes first and second ends 156 and 157 that are joined by first and second opposing sides 158 and 159 that form a generally rectangular profile. Second side 159 is provided with a receiver portion 161 that aligns with opening 150 when repair coupon 154 is seated within slot 131. A fastener member 165 is passed through opening 150 and into receiver portion 161. Fastener member 165 may be bonded to outer surface section 79 through a metallurgical bond (not shown) or joined to second end section 75 using other systems including both mechanical bonds and chemical/metallurgical bonds.

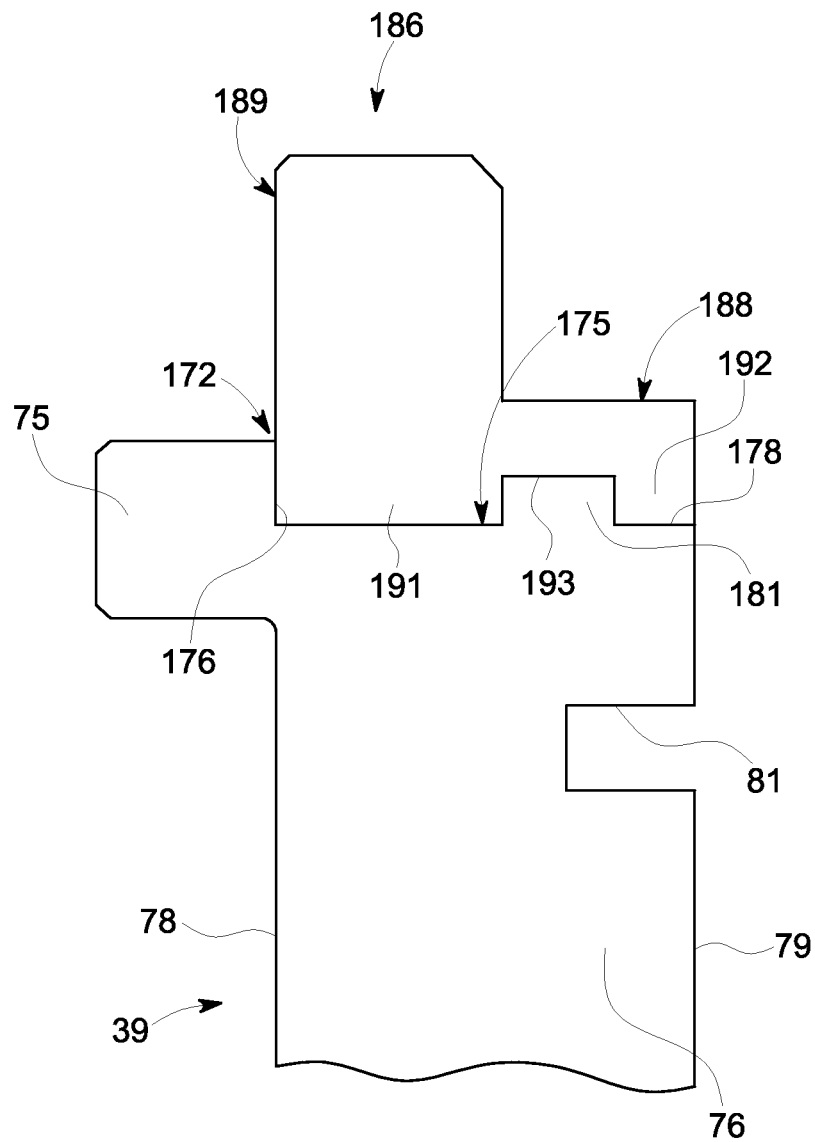
FIG. 6 is a partial plan view of a repair coupon mounted to a diaphragm rail member in accordance with still another aspect of the exemplary embodiment;

FIG. 6, wherein like reference numbers represent corresponding parts in the respective views, illustrates a machined surface 172 in accordance with an exemplary aspect formed in second end section 75 of second rail member 39. In addition to removing the original coupon, a repair coupon receiving element 175 is formed in second end section 75. Repair coupon receiving element 175 takes the form of a first slot 176 spaced from a second notch or slot 178 that form a boss 181. As shown, second slot 178 extends through outer surface section 79. A repair coupon 186 is secured to second end section 75 at coupon receiving element 175. Repair coupon 186 includes a base section 188 and a seal section 189. Base section 188 includes first and second tab elements 191 and 192 that form a boss receiving portion 193. With this arrangement, boss 181 nests within boss receiving portion 193. At this point, repair coupon 186 may be bonded to second end section 75 through mechanical and/or metallurgical bonds.

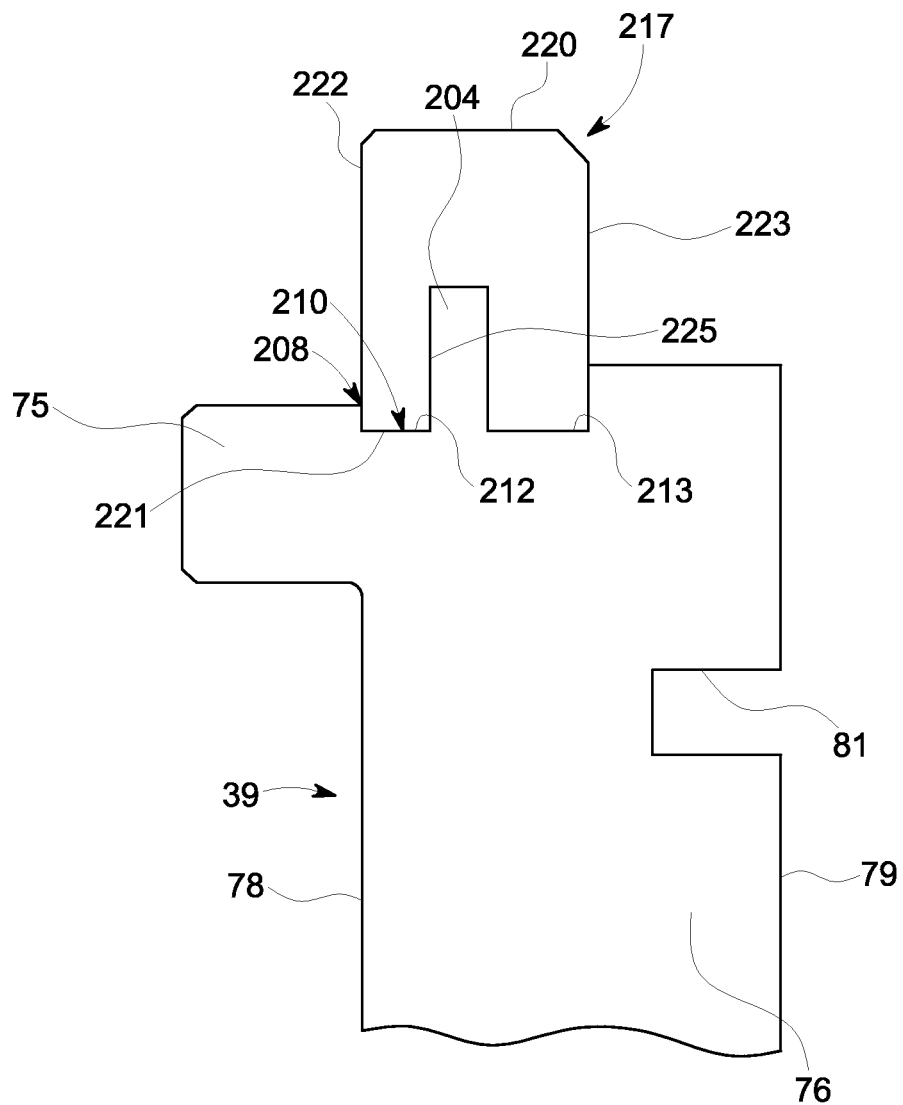
FIG. 7 is a partial plan view of a repair coupon mounted to a diaphragm rail member in accordance with still yet another aspect of the exemplary embodiment;

In FIG. 7, wherein like reference numbers represent corresponding parts in the respective views, an original coupon 204 is shown extending from second end section 75. Original coupon 204 is machined/blended to a desired thickness removing all oxidized and damaged material. In addition to processing original coupon 204, a machined surface 208 is

formed in second end section 75 to form a coupon receiving element. In the exemplary aspect shown, coupon receiving element 210 includes a first slot 212 arranged on one side (not separately labeled) of original coupon 204 and a second slot 213 formed on an opposing side (also not separately labeled) of original coupon 204. A repair coupon 217 is positioned over original coupon 204 and seated within slots 212 and 213. Repair coupon 217 includes first and second ends 220 and 221 that are joined by first and second opposing sides 222 and 223 forming a generally rectangular cross-section. Second end 221 is provided with a boss receiving portion 225 that is sized to receive original coupon 204. Once in position, repair coupon 217 is joined to second end section 75 through a mechanical and/or metallurgical bond.

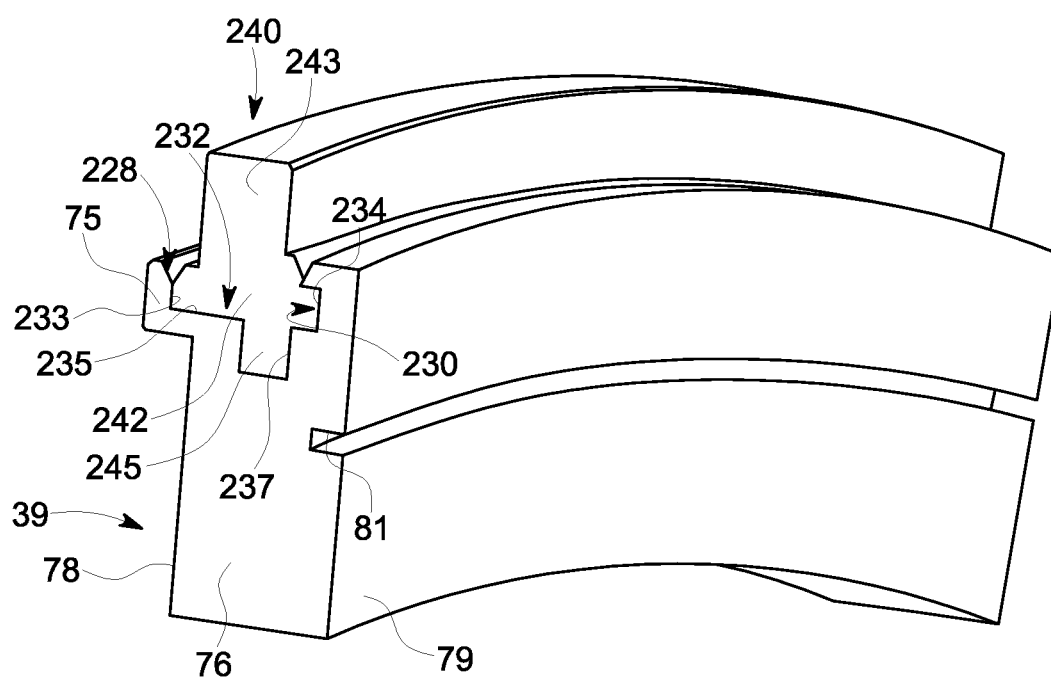
FIG. 8 is a partial plan view of a repair coupon mounted to a diaphragm rail member in accordance with yet still another aspect of the exemplary embodiment;

FIG. 8, wherein like reference numbers represent corresponding parts in the respective views, illustrates a machined surface 228 in accordance with another exemplary aspect formed in second end section 75. Machined surface 228 forms a coupon receiving element 230 that takes the form of a slot 232. Slot 232 includes first and second side walls 233 and 234 joined by a base wall 235. A groove 237 is formed in base wall 235. A repair coupon 240 is positioned within slot 232 and joined to second end section 75. Repair coupon 240 includes a base section 242 and a seal section 243. Base section 242 includes a tab element 245. Base section 242 is configured to nest within slot 232 with tab element 245 extending into groove 237. The engagement of tab element 245 and groove 237 provides additional support to repair coupon 240. Once installed into repair coupon receiving element 230, repair coupon 240 is joined to second end section 75 through a mechanical and/or a metallurgical bond.

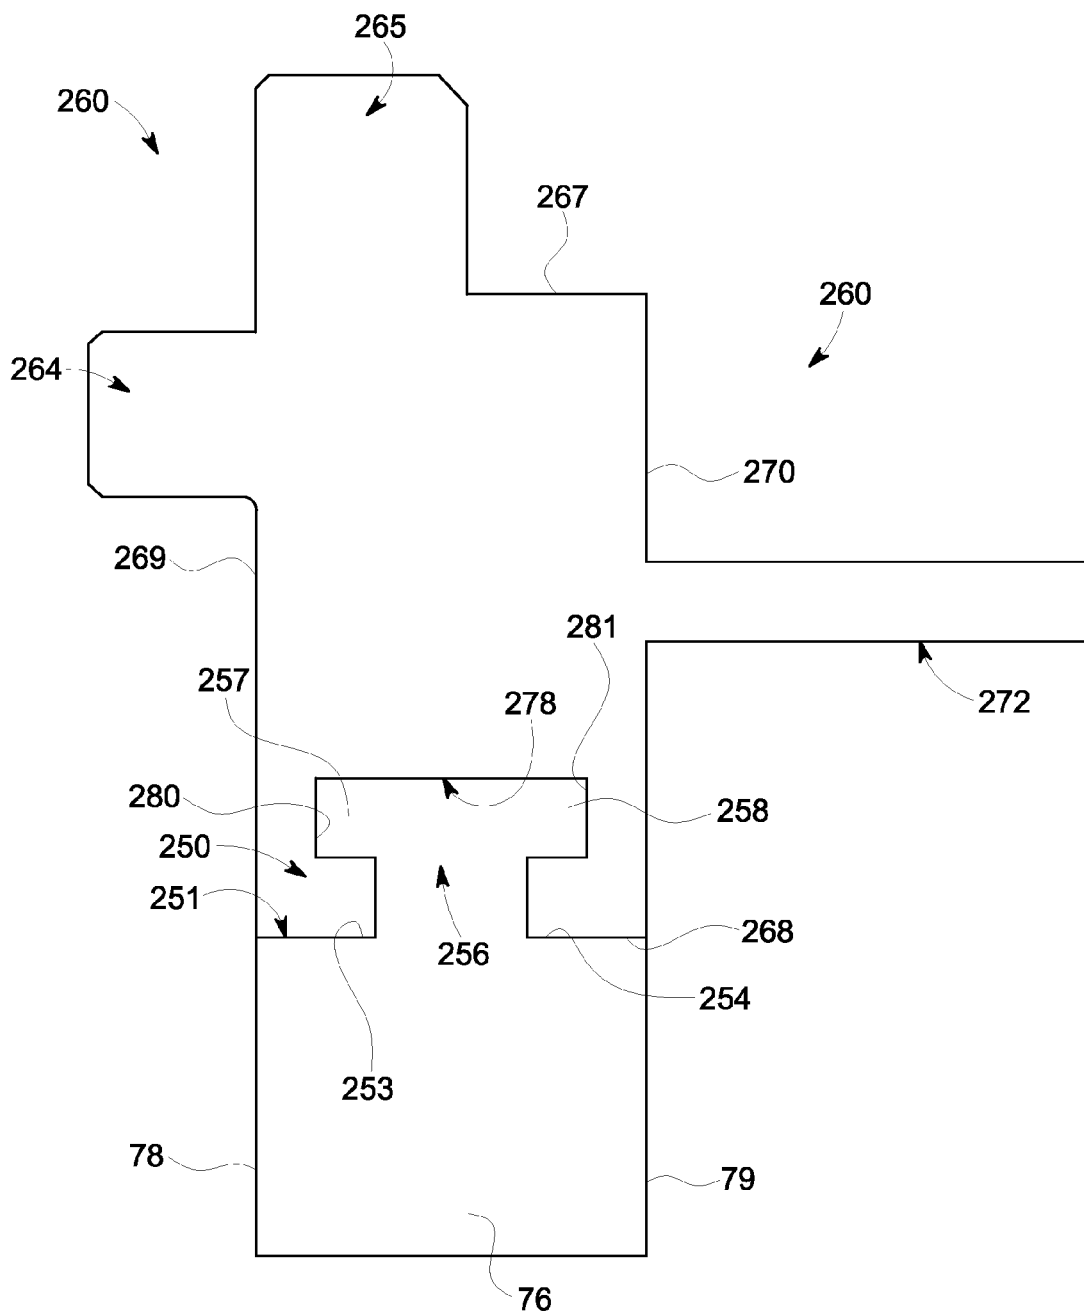
FIG. 9 is a partial plan view of a repair coupon mounted to a diaphragm rail member in accordance with still another aspect of the exemplary embodiment;

FIG. 9, wherein like reference numbers represent corresponding parts in the respective views, illustrates a machined surface 250 in accordance with still another exemplary aspect formed in second end section 75 of second rail member 39. Machined surface 250 represents a removal of a portion of material from second end section 75 that includes discourager seal mounting section 81. The removal of the material at second end section 75 may be necessary due to substantial damage, oxidation of second rail member 39. First and second slots 253 and 254 are formed in second end section 75. First slot 253 extends from inner surface section 78 into intermediate section 76. Second slot 254 is arranged opposite to first slot 253 and extends from outer surface section 79 into intermediate section 76. First and second slots 253 and 254 form a tab element 256 having first and second opposing extended regions 257 and 258 that form a generally t-shaped cross-section. A repair coupon 260 is mounted to second end section 75 at coupon receiving element 251.

Repair coupon 260 includes a base section 264 and a seal section 265. Base section 264 includes first and second opposing ends 267 and 268 that are joined by first and second opposing sides 269 and 270 to form a generally rectangular profile. Second side 270 is provided with a discourager seal 272 that replaces discourager seal mounting section 81, removed when forming coupon receiving element 251. Base section 264 also includes a central recess 278 formed in second end 268. Central recess 278 includes first and second extended portions 280 and 281 that are configured to receive first and second extended regions 257 and 258 of tab element 256. In accordance with the exemplary aspect shown, repair coupon 260 is mounted to second end section 75 by sliding tab element 256 through central recess 278. Once in position, repair coupon 260 is joined to second end section 75 by a mechanical and/or a metallurgical bond.

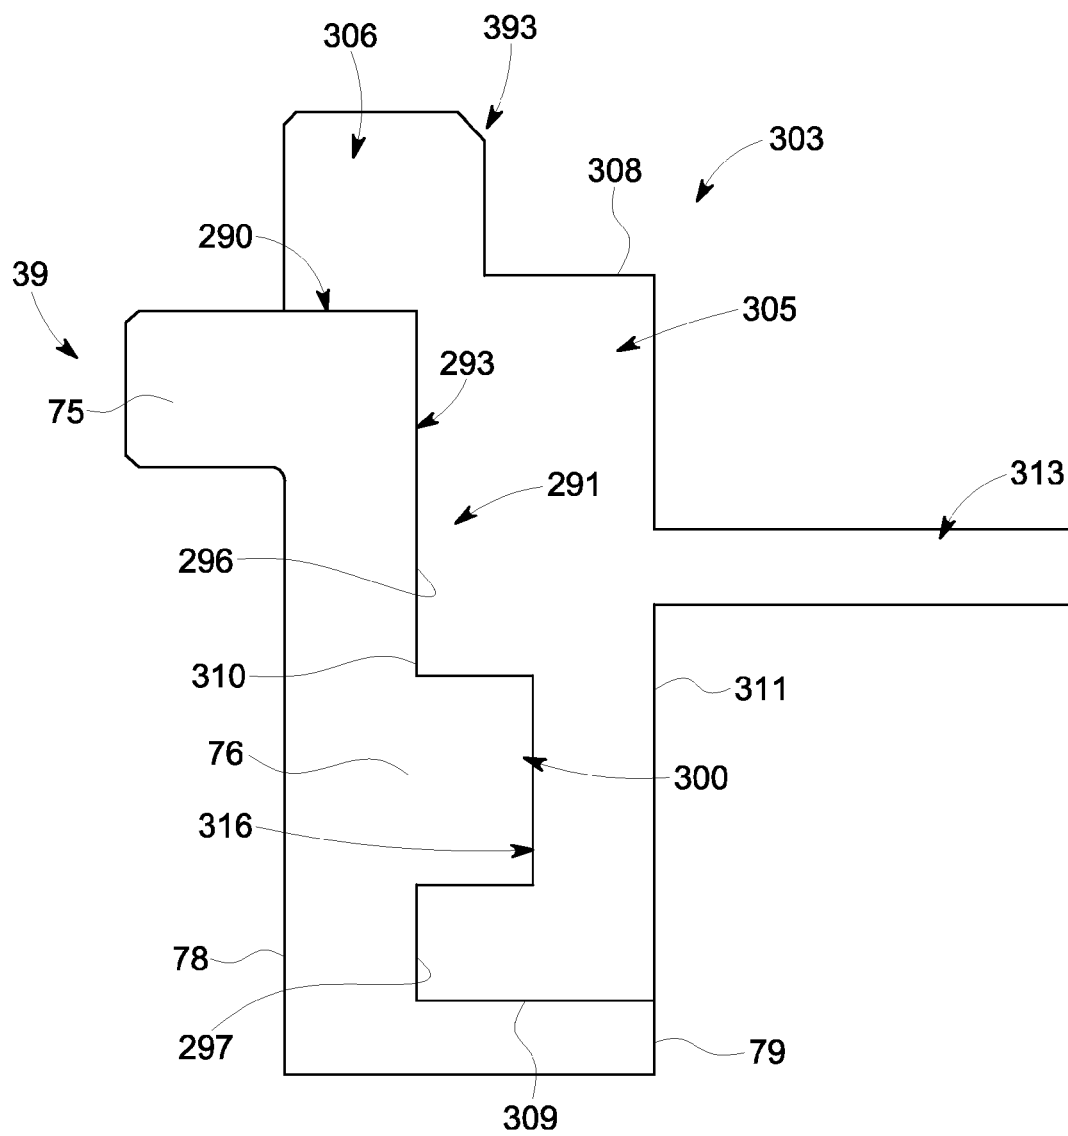
FIG. 10 is a partial plan view of a repair coupon mounted to a diaphragm rail member in accordance with yet another aspect of the exemplary embodiment;

FIG. 10, wherein like reference numbers represent corresponding parts in the respective views, illustrates first and

second machined surfaces 290 and 291 in accordance with yet another exemplary aspect formed in second end section 75. First machined surface 290 is formed in a terminal end portion (not separately labeled) of second end section 75 and second machined surface 291 is formed in outer surface section 79. A coupon receiving element 293 is formed in second machined surface 291. Coupon receiving element 293 includes a first groove or slot 296 spaced from a second slot 297 to form a boss 300. A repair coupon 303 is mounted to second end section 75 at coupon receiving element 293. Repair coupon 303 includes a base section 305 and a seal section 306. Base section 305 includes first and second opposing ends 308 and 309 that are joined by first and second opposing sides 310 and 311. Second side 311 includes a discourager seal 313 that replaces discourager seal mounting section 81 removed when forming first and second slots 296 and 297. First side 310 includes a boss receiving portion 316 that is configured to engage with and receive boss 300. Once in place, repair coupon 303 may be joined to second end section 75 using a mechanical and/or a metallurgical bond.

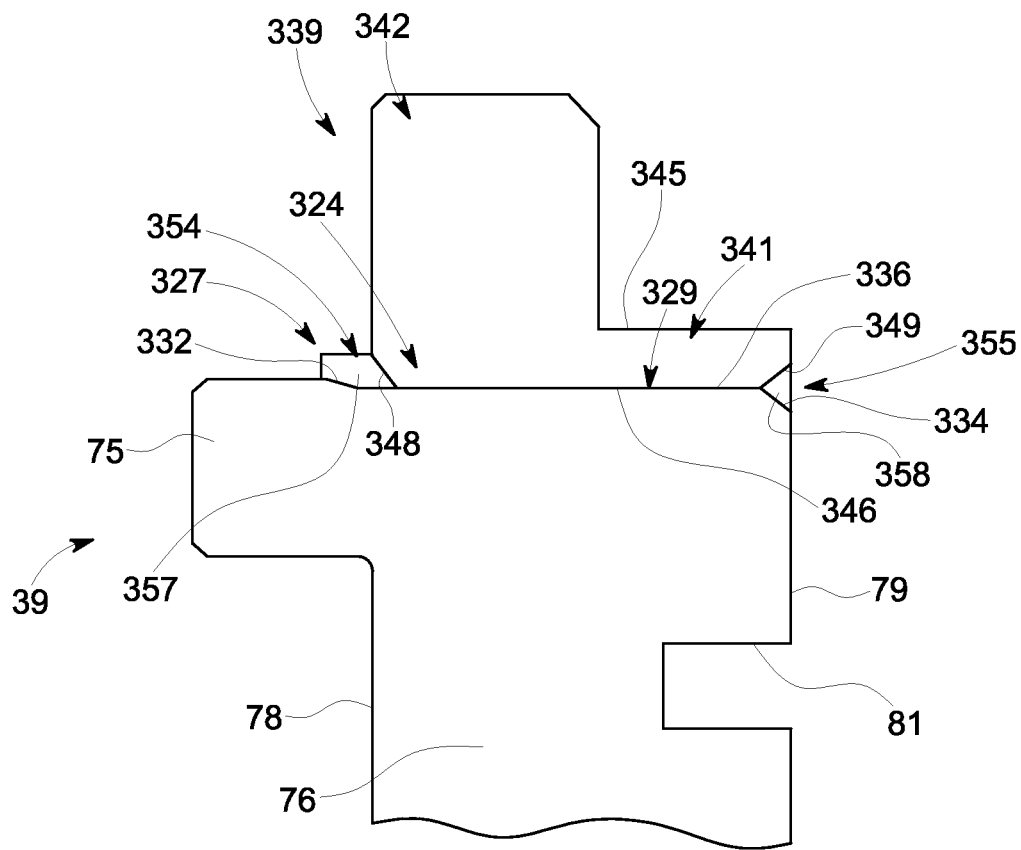
FIG. 11 is a partial plan view of a repair coupon mounted to a diaphragm rail member in accordance with another aspect of the exemplary embodiment;

FIG. 11, wherein like reference numbers represent corresponding parts in the respective views, illustrates a machined surface 324 in accordance with yet still another exemplary aspect formed in second end section 75. Machined surface 324 includes a first step section 327 that defines a coupon receiving element 329. A first angled surface 332 is provided at step section 327 and a second angled surface 334 is provided at outer surface section 79. A substantially horizontal planar surface 336 extends between first and second angled surfaces 332 and 334. A repair coupon 339 is provided on coupon receiving element 329. Repair coupon 339 includes a base section 341 that rests upon substantially horizontal planar surface 336 and a seal section 342. Base section 341 includes a first end 345 and a second end 346. A first angled section or chamfer 348 is formed on a first side (not separately labeled) of base section 341 and a second angled section or chamfer 349 is formed on a second side (also not separately labeled) of base section 341. When repair coupon 339 is positioned on substantially horizontal planar surface 336, first chamfer 348 aligns with first angled surface 332 and second chamfer 349 aligns with second angled surface 334. A first metallurgical bond 354 is formed between first chamfer 348 and first angled surface 332 and a second metallurgical bond 355 is formed between second chamfer 349 and second angled surface 334. First and second metallurgical bonds 354 and 355 take the form of welds 357 and 358 that join repair coupon 339 to second end section 75.

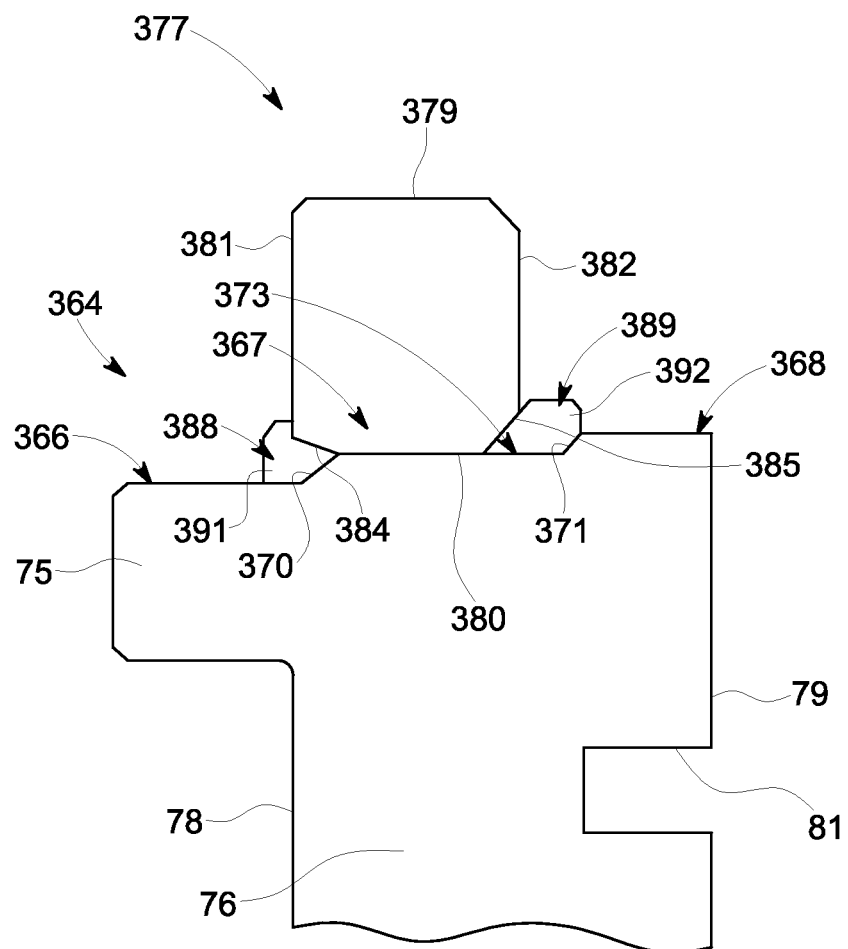
FIG. 12 is a partial plan view of a repair coupon mounted to a diaphragm rail member in accordance with yet still another aspect of the exemplary embodiment;

FIG. 12, wherein like reference numbers represent corresponding parts in the respective views, illustrates a machined surface 364 in accordance with yet still another aspect of the exemplary embodiment formed in second end section 75. Machined surface 364 includes a first step section 366 that leads to a second step section 367 and a third step section 368. First and second step sections 366 and 367 are separated by a first angled surface 370 and second and third step sections 367 and 368 are separated by a second angled surface 371. In accordance with the exemplary aspect shown, second step section 367 defines a coupon receiving element 373. A repair coupon 377 is provided on second step section 367. Repair coupon 377 includes first and second ends 379 and 380 joined by first and second opposing sides 381 and 382 that form a generally rectangular profile. A first chamfer 384 is formed between second end 380 and first side 381 and a second chamfer 385 is formed between second end 380 and second side 382. When repair coupon 377 is supported on coupon receiving element 373, first chamfer 384 aligns with first angled surface 370 and second chamfer 385 aligns with sec-

ond angled surface 371. A first metallurgical bond 388 is formed between first chamfer 384 and first angled surface 370 and a second metallurgical bond 389 is formed between second chamfer 385 and second angled surface 371. First and second metallurgical bonds 388 and 389 take the form of first and second welds 391 and 392 that join repair coupon 377 to second end section 75.

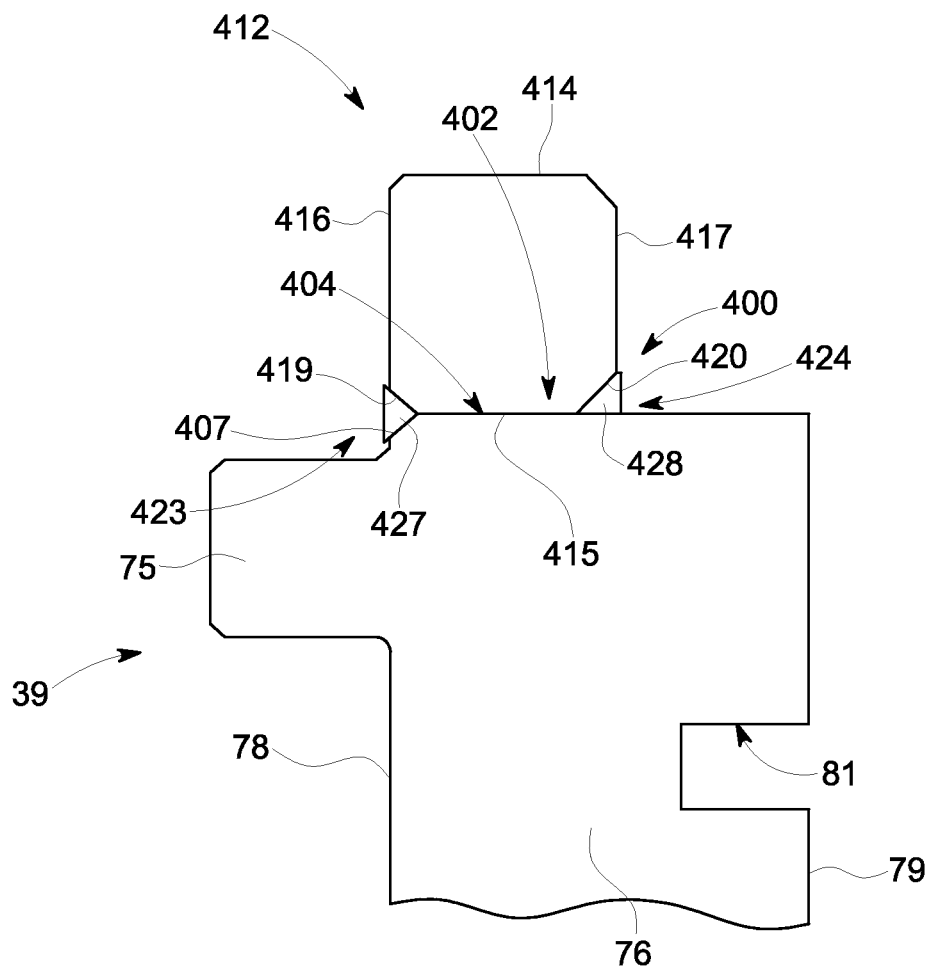
FIG. 13 is a partial plan view of a repair coupon mounted to a diaphragm rail member in accordance with yet another aspect of the exemplary embodiment;

FIG. 13, wherein like reference numbers represent corresponding parts in the respective views, illustrates a machined surface 400 in accordance with yet another aspect of the exemplary embodiment formed in second end section 75. Machined surface 400 includes a substantially horizontal planar surface 402 that eliminates any portion of the original coupon on second end section 75. Substantially horizontal planar surface 402 defines a coupon receiving element 404. An angled surface 407 is formed in machined surface 400 adjacent inner surface section 78. A repair coupon 412 is mounted to coupon receiving element 404. Repair coupon 412 includes first and second opposing ends 414 and 415 that are joined by first and second opposing sides 416 and 417 that form a generally rectangular profile. A first chamfer 419 is formed between second end 415 and first side 416 and a second chamfer 420 is formed between second end 415 and second side 417. First chamfer 419 aligns with angled surface 407 formed in machined surface 400 when repair coupon 412 is supported upon coupon receiving element 404. A first metallurgical bond 423 is formed between first chamfer 419 and angled surface 407 and a second metallurgical bond 424 is formed between second chamfer 420 and machined surface 400. First and second metallurgical bonds 423 and 424 constitute welds 427 and 428 that join repair coupon 412 to second end section 75.

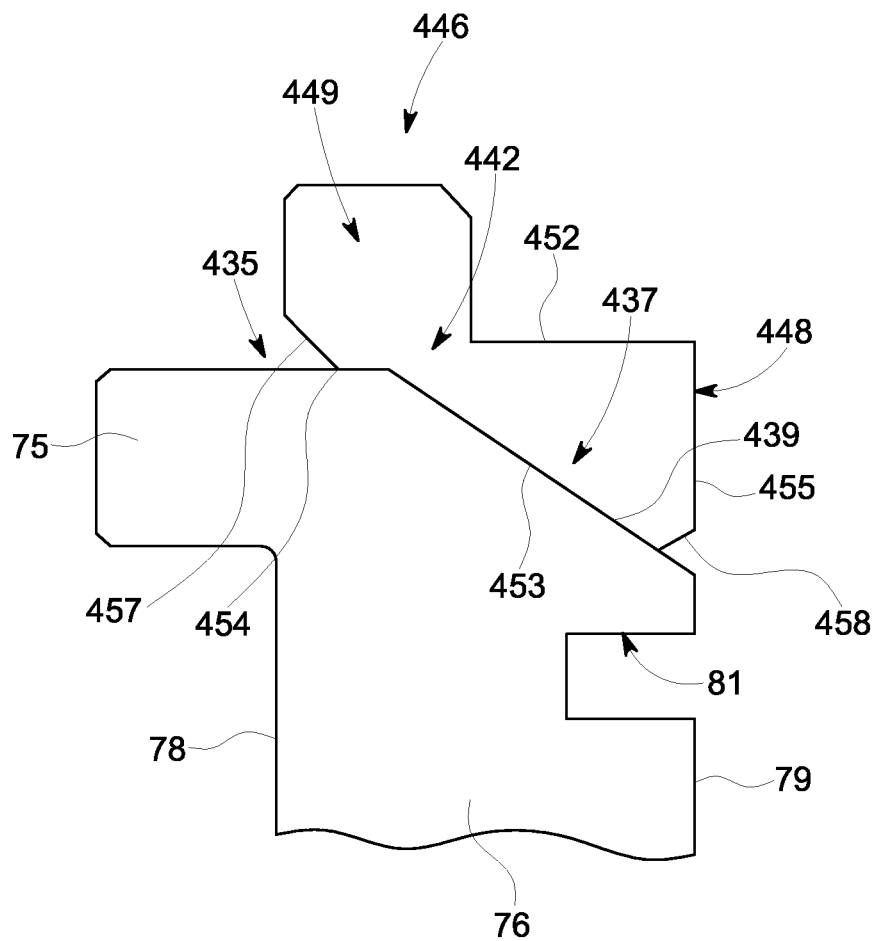
FIG. 14 is a partial plan view of a repair coupon mounted to a diaphragm rail member in accordance with still another aspect of the exemplary embodiment;

FIG. 14, wherein like reference numbers represent corresponding parts in the respective views, illustrates a first machined surface 435 in accordance with still another aspect of the exemplary embodiment formed in second end section 75. Second end section 75 is also shown to include a second machined surface 437. Second machined surface defines an angled surface or section 439 that extends between outer surface section 79 and first machined surface 435. Angled section 439 together with first machined surface 435 defines a coupon receiving element 442. A repair coupon 446 is positioned upon coupon receiving element 442 and joined to second end section 75. Repair coupon 446 includes a base section 448 and a seal section 449. Base section 448 includes first and second opposing ends 452 and 453 and first and second opposing sides 454 and 455. Second end 453 includes a first section (not separately labeled) configured to mate with first machined surface 435 and a second section (also not separately labeled), angled relative to the first section, configured to mate with angled section 439. A first chamfer 457 is provided between second end 453 and first side 454 and a second chamfer 458 is provided between second end 453 and second side 455. Chamfers 457 and 458 provide structure for receiving a metallurgical bond (not shown) that joins repair coupon 446 to second end section 75.

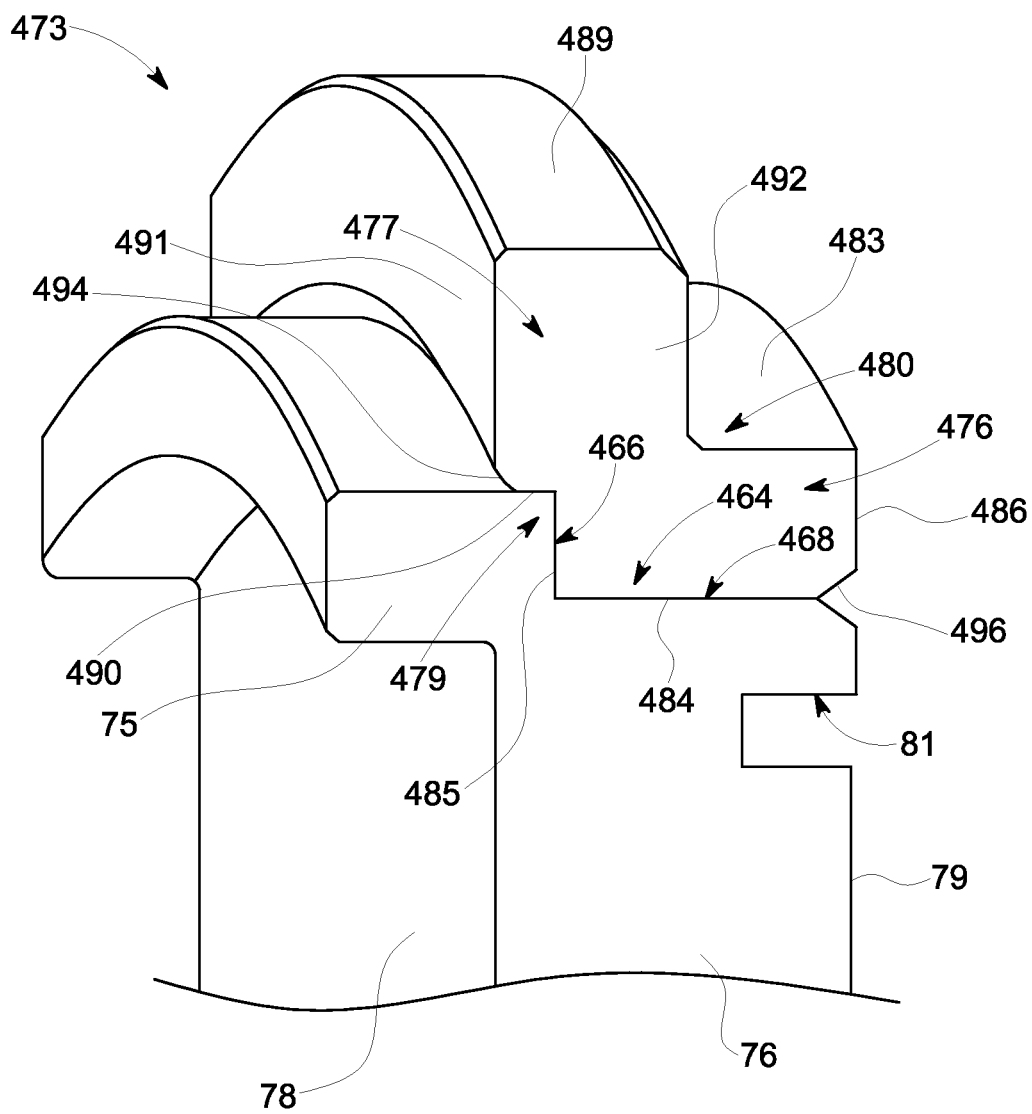
FIG. 15 is a partial plan view of a repair coupon mounted to a diaphragm rail member in accordance with another aspect of the exemplary embodiment;

FIG. 15, wherein like reference numbers represent corresponding parts in the respective views, illustrates a machined surface 464 in accordance with another aspect of the exemplary embodiment formed in second end section 75. Machined surface 464 includes a step region 466 that forms a coupon receiving element 468. A repair coupon 473 is positioned upon second end section 75 at coupon receiving element 468. Repair coupon 473 includes a base section 476 and a seal section 477. Seal section 477 is off-set relative to base section 476 to form a first step zone or region 479 and a second step zone or region 480. Base section 476 includes

first and second opposing ends 483 and 484 joined by first and second opposing sides 485 and 486. Similarly, seal section 477 includes first and second opposing ends 489 and 490 joined by first and second opposing sides 491 and 492. A first chamfer 494 is formed between second end 490 and first side 491 and a second chamfer 496 is formed between second end 484 and second side 486. First and second chamfers 494 and 496 provide structure for receiving a metallurgical bond (not shown) that joins repair coupon 473 to second end section 75. At this point it should be understood that repair coupon 473 can be formed from a number of repair coupon segments 498-500 as shown in FIG. 16.

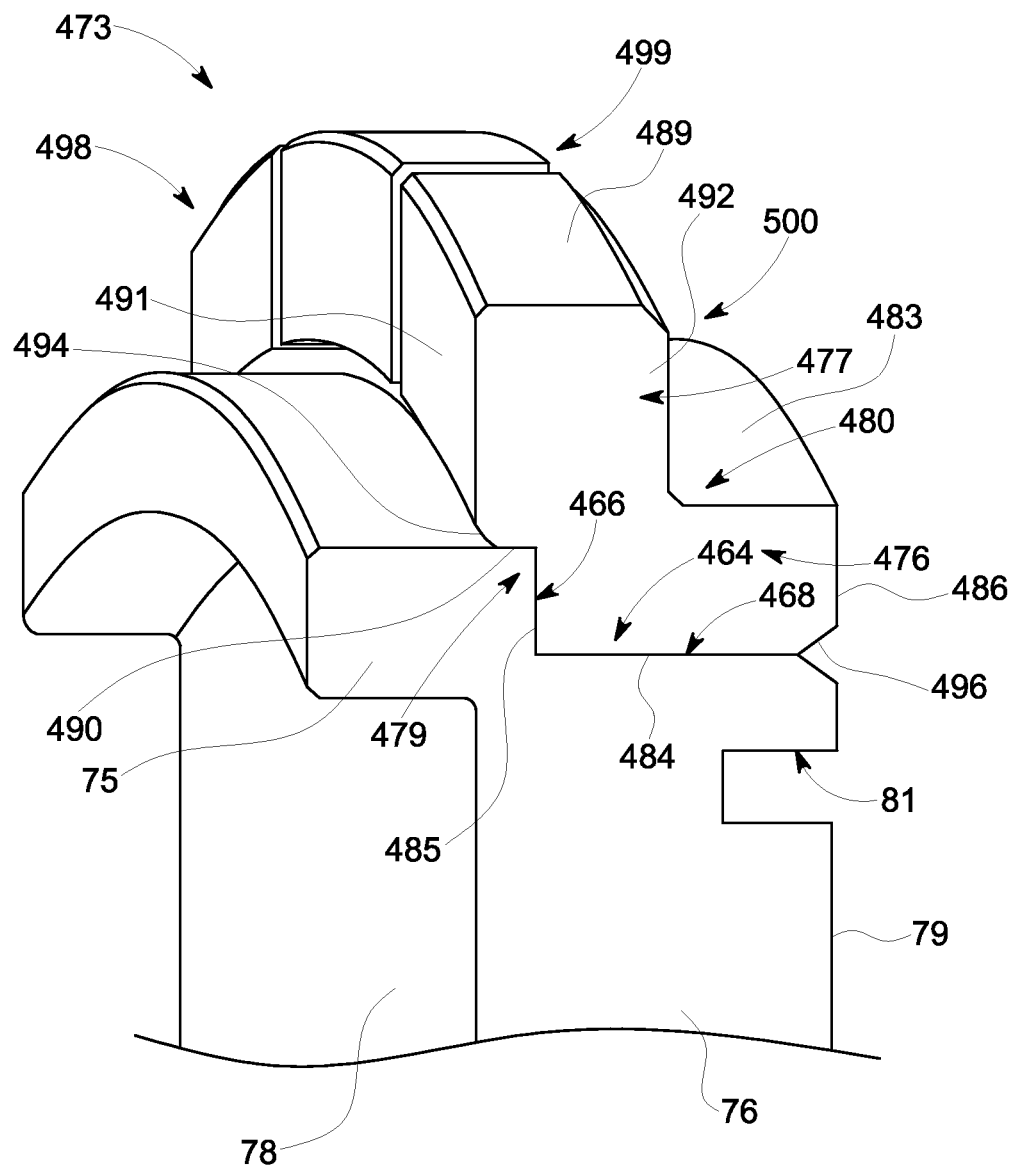
FIG. 16 is a partial plan view of a repair coupon mounted to a diaphragm rail member in accordance with still yet another aspect of the exemplary embodiment; and
